SPECIAL REPORT: SR2008/003

Dynamic sled testing of the 'Tummy Shield' cushion (test details and results)

Client: Tummy Shield Company

Test item: 'Tummy Shield' cushion.

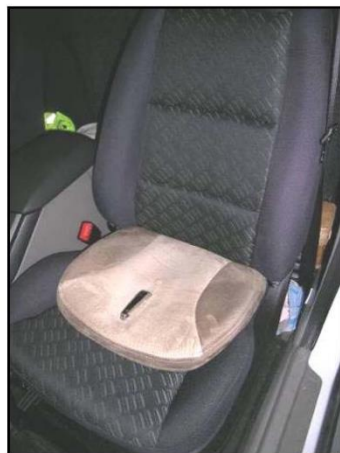
Cushion placed on a vehicle seat

The 'Tummy Shield' cushion primarily consists of a section of foam moulded onto a steel plate incorporating a metal guide (hook). It is designed to help reduce the risks of women and foetuses from motor vehicle injury during pregnancy by altering the geometry of the lap section of a conventional three-point seatbelt. The cushion (shown below) is placed on a vehicle seat and secured by means of a webbing strap and buckle at the back of the seat. The occupant sits on the cushion and wears the seatbelt as normal. The middle portion of the lap belt is then placed under the hook while adjusting any slack in the seatbelt.

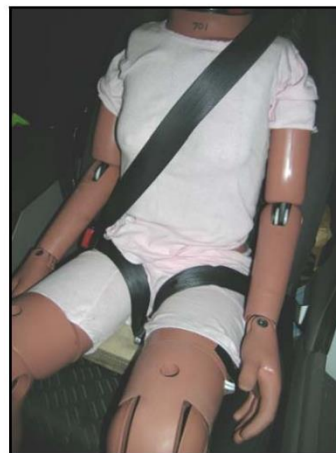
Cushion fitted under test dummy

The test method involved mounting a vehicle seat to the test sled which was then subjected to a frontal impact deceleration of approximately 28 g. The first test (# S080327) involved the test dummy restrained by a three-point seatbelt in the vehicle seat. The second test (# S080328) was similar and involved the 'Tummy Shield' cushion fitted under the test dummy with the lap section of the seatbelt directed under the hook.

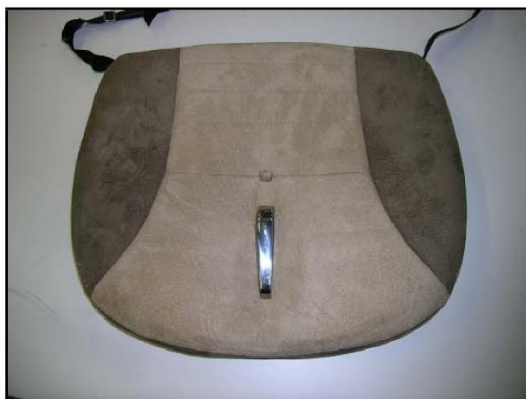
Photograph 9
'Tummy shield' cushion

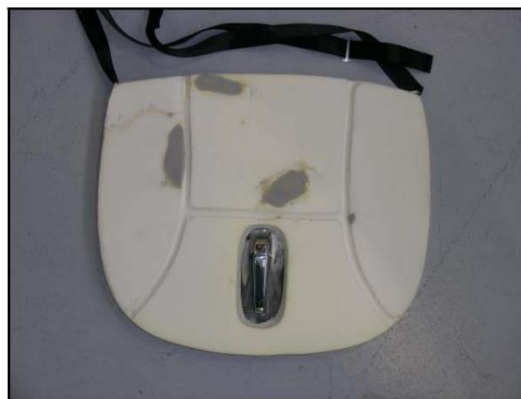
Photograph 10
Cushion with cover removed

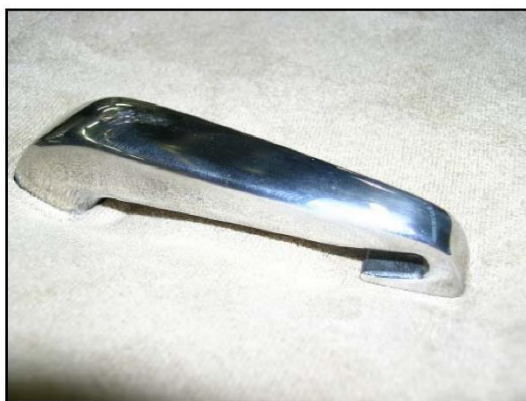
Photograph 11
Hook detail on cushion

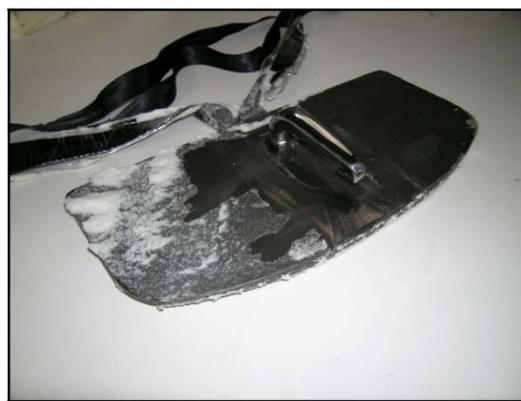
Photograph 12
Metal plate inside cushion

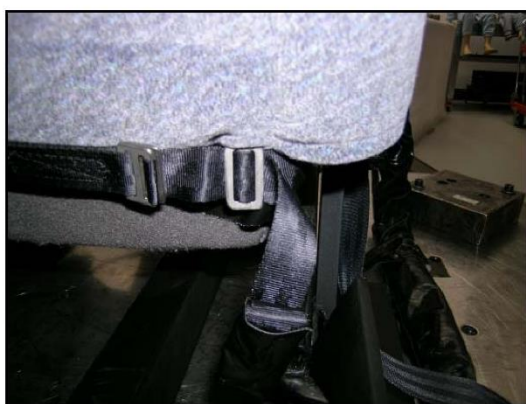
Photograph 13
Cushion retention strap fastened to vehicle seat

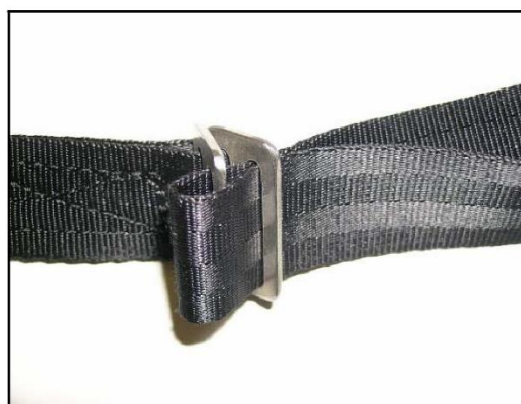
Photograph 14
Detail of three-bar buckle on cushion strap

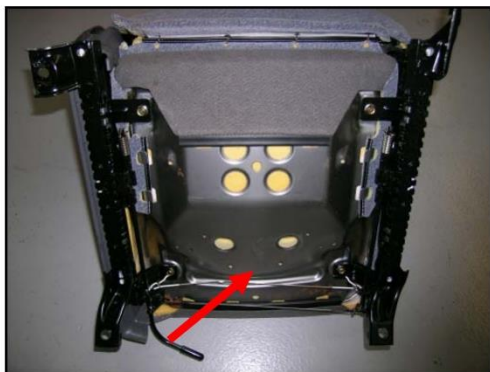
Photograph 19 - S080327 Post-test
Minor deformation of metal panel under seat pan

Test No.	Component	Comments
S080327	Vehicle seat	<p>Inspection revealed no apparent deformation of the seat anchorages and the adjustment systems remained locked in position.</p> <p>The seat revealed some minor deformation of the metal panel under seat pan.</p>
	Seatbelt	<p>The dummy was effectively restrained in the vehicle seat by the seatbelt with no apparent deformation of the belt anchorages.</p> <p>The seatbelt revealed partial separation of the spring cover on retractor assembly, deformation of rigid plate on buckle assembly, and abrasion of webbing.</p> <p>The seatbelt buckle was capable of manual release.</p>
	'Tummy shield' Cushion	n/a
S080328	Vehicle seat	<p><i>The deformation of the metal panel under the seat pan from the first test was repaired before this test to obtain as near as possible similar profile.</i></p> <p>Inspection revealed no apparent deformation of the seat anchorages and the adjustment systems remained locked in position.</p> <p>The seat revealed some minor deformation of the metal panel under seat pan.</p>

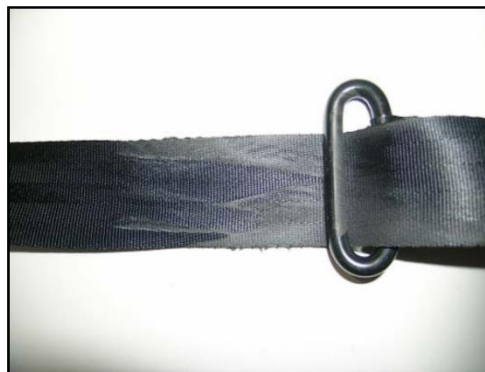
Photograph 20 - S080327 Post-test
Abrasion of seatbelt webbing through sash guide

Seatbelt	<p>The dummy was effectively restrained in the vehicle seat by the seatbelt with no apparent deformation of the belt anchorages.</p> <p>The seatbelt revealed partial separation of the spring cover on retractor assembly, deformation of rigid plate on buckle assembly, and abrasion of webbing.</p> <p>The seatbelt buckle was capable of manual release. The lap section of the belt needed to be unthreaded from under the hook to allow removal of the dummy (occupant).</p>
	'Tummy shield' Cushion	<p>No damage was visible to the cushion or hook.</p> <p>The retention strap securing the cushion revealed tearing and fraying of webbing.</p>

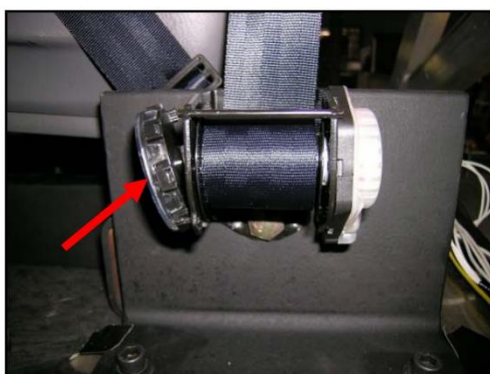
Photograph 21 - S080327 Post-test
Partial separation of spring cover on seatbelt retractor

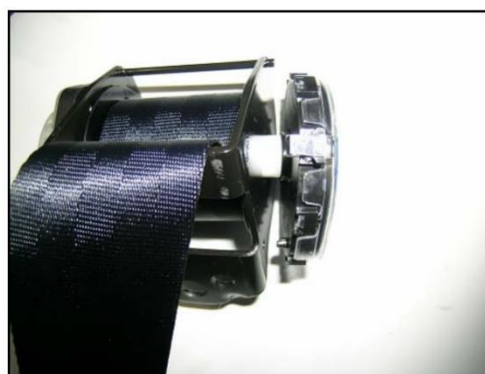
Photograph 22 - S080327 Post-test
Detail of spring cover assembly

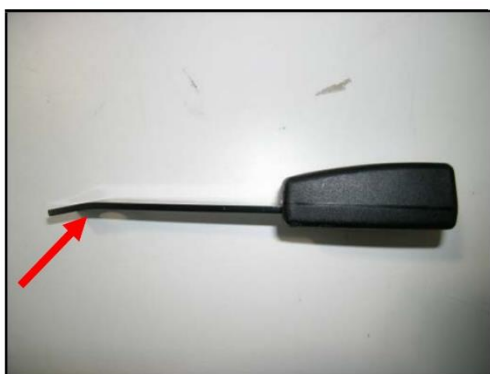
Photograph 23 - S080327 Post-test
Deformation rigid buckle on seatbelt assembly

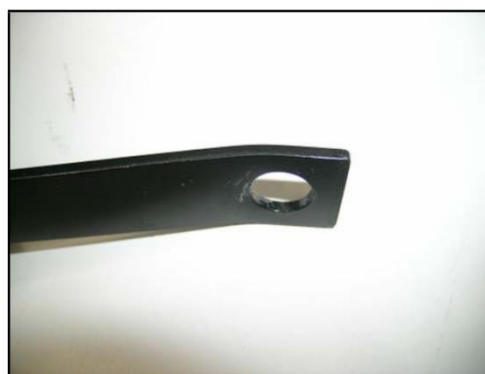
Photograph 24 - S080327 Post-test
Detail of rigid buckle
